CT23HD13

KIT FEATURES

- Double DIN Radio Provision
- Stacked ISO Units Provision

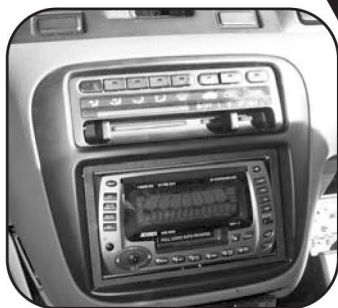
KIT COMPONENTS

- A) Radio Housing • B) Rear Support Tray • C) ISO Brackets
- D) Mounting Bracket (Acura legend) • E) (2) #8 x 1/2" Phillips Pan Head Screws
- F) (6) #6 x 1/4" Phillips Flat Head Screws

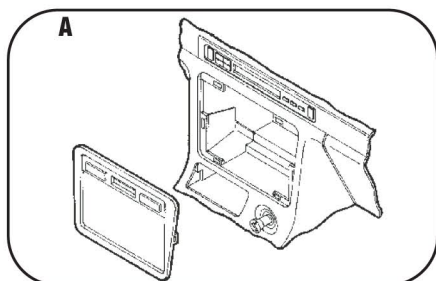
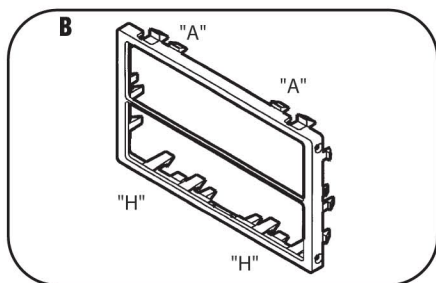
ACURA CL 1997-1999

- 1 Disconnect the negative battery terminal to prevent an accidental short circuit.
- 2 Unclip the radio trim bezel and disconnect the clock and climate control wiring. Remove (2) 8mm hex-head screws securing the factory head unit and disconnect the wiring. (Fig. A)
- 3 Cut and remove all mounting clips on the **Radio Housing** EXCEPT clips "A" and "H". (Fig. B)
Skip to step #3b on Page 10.

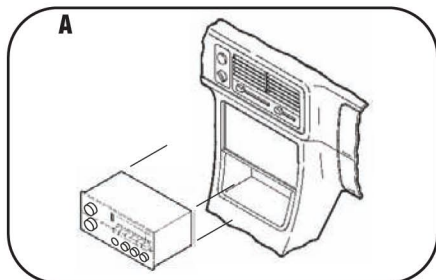
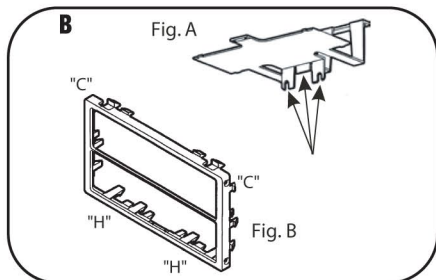
ACURA INTEGRA 1990-1993

- 1 Disconnect the negative battery terminal to prevent an accidental short circuit.
- 2 Remove (3) screws from each side of the center console and remove the console. Remove (2) screws securing the factory head unit to the sub-dash support bracket. Slide the head unit/pocket assembly out and disconnect the wiring. (Fig. A)
- 3 Cut and remove the mounting tabs from the bottom of the **Rear Support Tray** (Fig. A). Cut and remove all mounting clips on the **Radio Housing** EXCEPT clips "C" and "H" (Fig. B).
Skip to step #3b on Page 10.

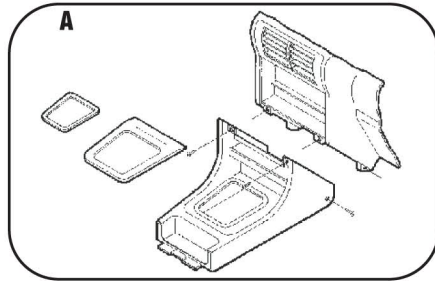
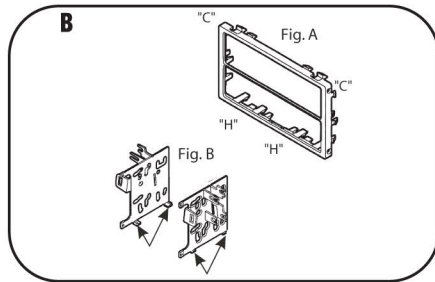
ACURA INTEGRA 1994-2001

- 1 Disconnect the negative battery terminal to prevent an accidental short circuit.
- 2 Remove the cover cap located under the emergency brake and remove (2) screws exposed. Remove (2) screws from the rear corners of the lower dash trim bezel and remove. Remove the ashtray and (2) screws exposed. Unsnap the ashtray housing and disconnect the cigarette lighter harness. Remove the gear shifter knob and unsnap the shifter trim. Remove (2) screws below the radio opening and remove the upper dash trim bezel. Remove (2) 8mm screws securing the factory head unit and disconnect the wiring. (Fig. A)
- 3 Cut and remove all mounting clips on the **Radio Housing EXCEPT** clips "C" and "H" (Fig. A). Cut and remove the slots on the bottom of the **ISO Brackets** (Fig. B). (**THE REAR SUPPORT TRAY WILL NOT BE USED**). (Fig. B)
Skip to step #3b on Page 10.

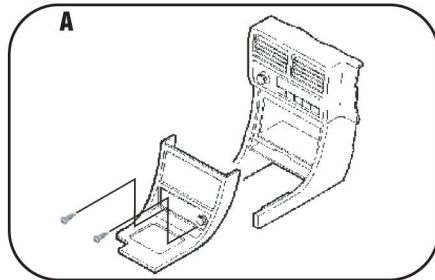
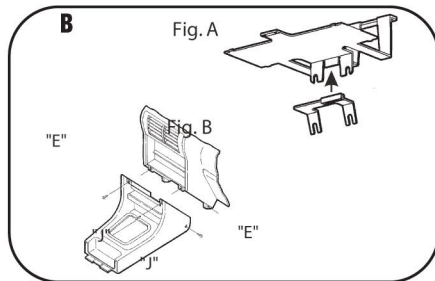
ACURA LEGEND 1990-1996

- 1 Disconnect the negative battery terminal to prevent an accidental short circuit.
- 2 Remove (2) screws below the ashtray. Unclip the dash trim bezel. Disconnect the cigarette lighter wiring and remove the bezel. Remove (2) bolts securing the rear of the factory head unit and disconnect the wiring. (Fig. A)
- 3 Attach the **Mounting Bracket** to the bottom of the **Rear Support Tray** (Fig. A). Cut and remove all mounting clips on the **Radio Housing EXCEPT** clips "E" and "J". (Fig. B)
Skip to step #3b on Page 10.

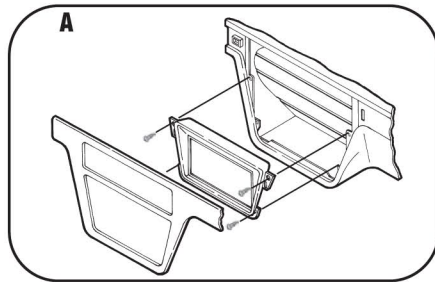
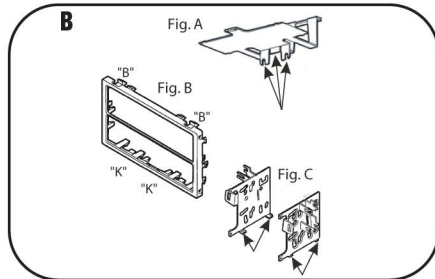
ACURA TL 1996-1998

- 1 Disconnect the negative battery terminal to prevent an accidental short circuit.
- 2 Using a small screwdriver, unclip the perimeter of the radio trim bezel. Disconnect the climate control and rear defroster wiring and remove the bezel. Remove (4) Phillips screws securing the factory head unit/trim bezel assembly. Loosen (2) Phillips screws securing the back of the head unit to the metal housing and slide the unit out. (It is NOT necessary to remove the screws securing the metal housing to the bezel). Disconnect the wiring. (Fig. A)
- 3 Cut and remove the mounting tabs (Fig. B) from the bottom of the **Rear Support Tray** (Fig. A). Cut and remove all mounting clips on the **Radio Housing** EXCEPT clips "B" and "K" (Fig. B). Cut and remove the slots on the bottom of the **ISO Brackets** (Fig. C).
Skip to step #3b on Page 10.

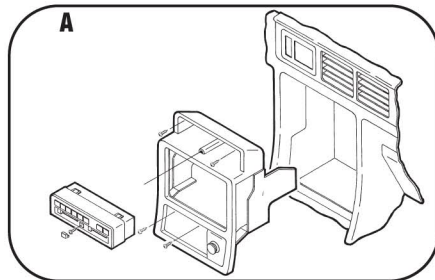
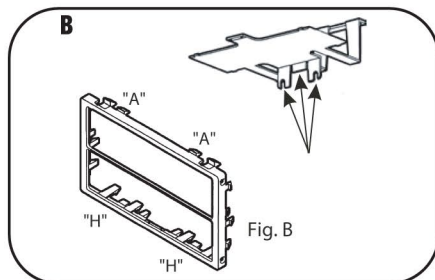
ACURA VIGOR 1992-1994

- 1 Disconnect the negative battery terminal to prevent an accidental short circuit.
- 2 Remove the access cap from the climate control cluster and (1) screw exposed. Unclip the cluster and remove (2) screws exposed. Remove the ashtray and (2) Phillips screws exposed. Remove the cover caps from each front corner of the center console and the screws exposed. Open the storage compartment, lift up the carpet and remove (2) screws exposed. Lift up on the center console and remove. Unclip the radio trim bezel and disconnect the wiring. Remove (2) bolts from the back of the factory head unit and disconnect the wiring. (Fig. A)
- 3 Cut and remove the mounting tabs from the bottom of the **Rear Support Tray** (Fig. A). Cut and remove all mounting clips on the **Radio Housing** EXCEPT clips "A" and "H" (Fig. B).
Skip to step #3b on Page 10.

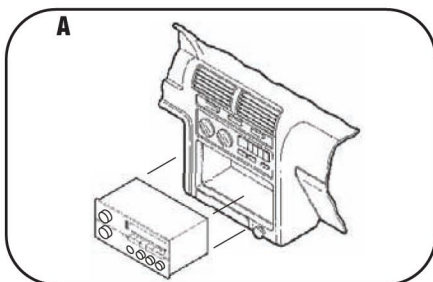
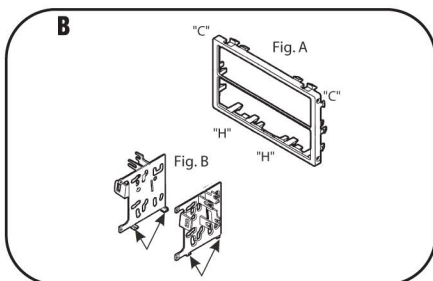
HONDA ACCORD 1990-1993

- 1 Disconnect the negative battery terminal to prevent an accidental short circuit.
- 2 Remove (4) screws from the lower portion of the center console. Remove the gear shifter knob and lift the console out. Remove the ashtray and ashtray bracket. Remove (2) screws from the bottom of the head unit support, slide the unit out and disconnect the wiring. (Fig. A)
- 3 Cut and remove all mounting clips on the **Radio Housing** EXCEPT clips "C" and "H" (Fig. A). Cut and remove the slots on the bottom of the **ISO Brackets** (Fig. B). (**THE REAR SUPPORT TRAY WILL NOT BE USED**).

(Fig. B) Skip to step #3b on Page 10.

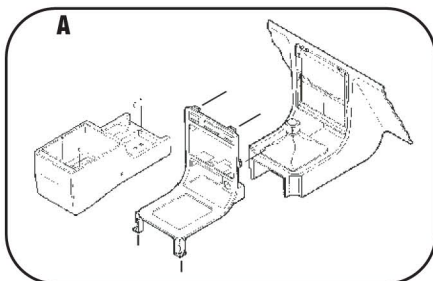
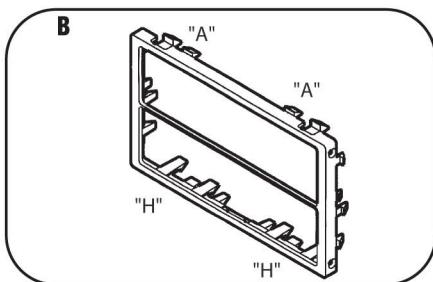
HONDA ACCORD 1994-1997

- 1 Disconnect the negative battery terminal to prevent an accidental short circuit.
- 2 Remove the ashtray and (1) 3/4" #8 Phillips screw exposed. Open the storage compartment and remove (2) #8 Phillips screws exposed. Remove the cupholder tray and (3) #8 Phillips screws inside. Lift the center console out and remove (2) Phillips screws exposed at the base of the dash trim bezel. Unclip the bezel and remove. Remove (2) hex-head screws securing the factory head unit and disconnect the wiring. (Fig. A)
- 3 Cut and remove all mounting clips on the **Radio Housing** EXCEPT clips "A" and "H". (Fig. B) Skip to step #3b on Page 10.

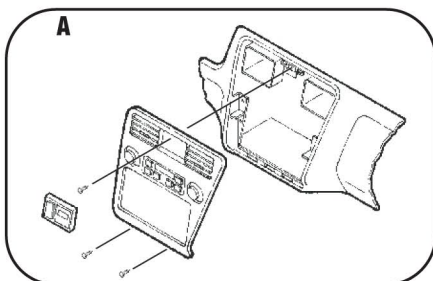
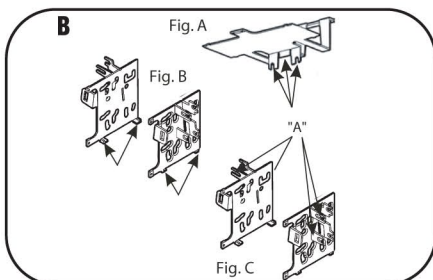
HONDA ACCORD 1998-2002

- 1 Disconnect the negative battery terminal to prevent an accidental short circuit.
- 2 Unsnap the clock panel, disconnect the wiring and remove. Remove (1) Phillips screw exposed in the clock cavity. Remove (2) Phillips screws below the factory head unit. Unclip the radio trim bezel and disconnect the wiring. Remove (4) Phillips screws securing the factory head unit assembly and disconnect the wiring. Remove (2) screws securing the factory pocket to the assembly. (Fig. A)
- 3 Cut and remove the mounting tabs from the bottom of the **Rear Support Tray** (Fig. A). Cut and remove the slots on the bottom of the **ISO Brackets** (Fig. B). Locate tabs "A" on the ISO Brackets for mounting, cut and remove tabs "B" (Fig. C). Cut and remove all mounting clips on the **Radio Housing**. (Fig. B) Skip to step #3b on Page 10.

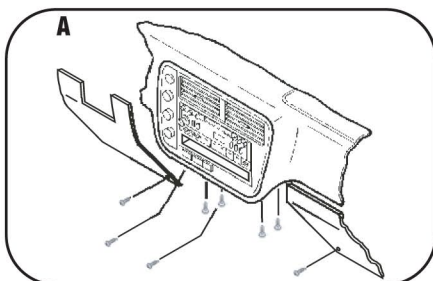
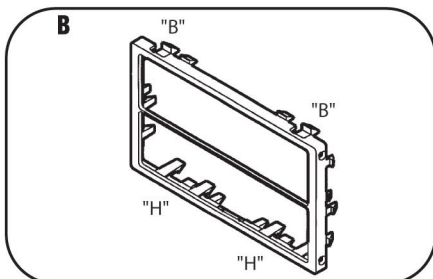
HONDA CIVIC 1999-2000

- 1 Disconnect the negative battery terminal to prevent an accidental short circuit.
- 2 Remove (2) Phillips screws from the bottom edge of the glove box door and remove the door. Remove (3) Phillips screws from the lower steering column panel. Pull straight down on the lower steering column panel and remove the panel. Remove (2) Phillips screws under the climate controls. Remove (4) Phillips screws from the lower dash location. Remove (4) Phillips screws securing the bottom of the dash trim bezel/head unit assembly and pull the assembly out as far as possible. Cut the zip ties securing the head unit and climate control wires, slide dash trim bezel/head unit assembly from the dash cavity and disconnect the wiring. (Fig. A)
- 3 Cut and remove all mounting clips on the **Radio Housing** EXCEPT clips "B" and "H". (Fig. B) Skip to step #3a on Page 9.

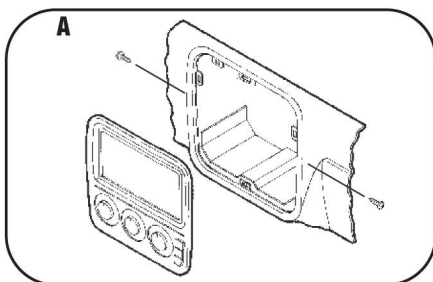
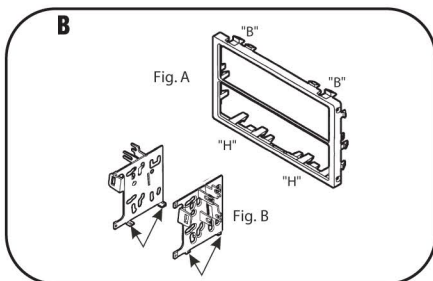
HONDA CRV 1997-2001

- 1 Disconnect the negative battery terminal to prevent an accidental short circuit.
- 2 Open the glove box, squeeze the retaining clips and remove the stoppers. Lower the glove box and remove (2) Phillips screws from the left edge. Remove (2) Phillips screws from the lower steering column panel and remove. Unclip the lower console cover (below the ashtray and pocket) and remove. Remove (2) Phillips screws from the base of the center console, open the console pocket and remove the (4) outer screws exposed. Unclip the center console and remove. Remove (2) Phillips screws securing the radio trim bezel, disconnect the wiring, and remove the trim bezel/head unit assembly. Remove (4) Phillips screws securing the head unit to the bezel and remove. (Fig. A)

- 3 Cut and remove all mounting clips on the **Radio Housing** EXCEPT clips "B" and "H" (Fig. A). Cut and remove the slots on the bottom of the **ISO Brackets** (Fig. B). Skip to step #3a on Page 9.

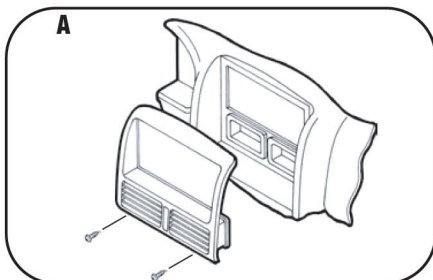
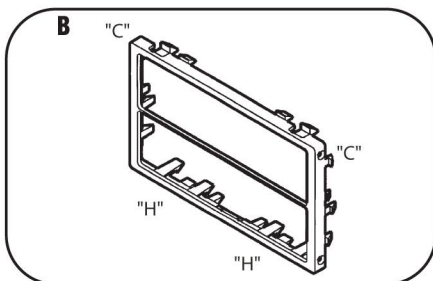
HONDA CRV 2002-2006

- 1 Disconnect the negative battery terminal to prevent an accidental short circuit.
- 2 Remove (2) Phillips from the bottom edge of the radio trim bezel. Unclip the trim bezel and remove. Remove (4) Phillips screws securing the factory head unit and disconnect the wiring. (Fig. A)
- 3 Cut and remove all mounting clips on the **Radio Housing** EXCEPT clips "C" and "H". (Fig. B) Skip to step #3a on Page 9.

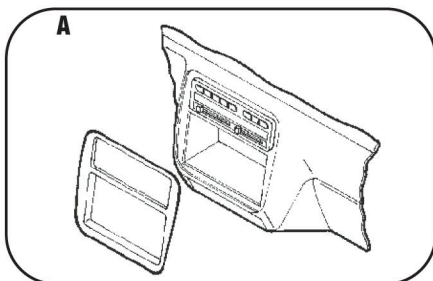
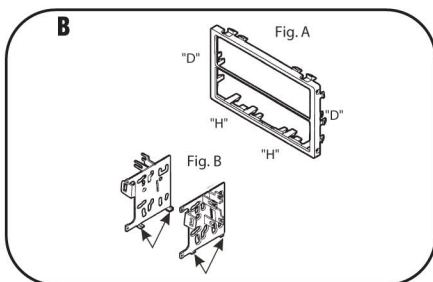
ISUZU OASIS 1996-1999

- 1 Disconnect the negative battery terminal to prevent an accidental short circuit.
- 2 Lower the glove box assembly. Remove (2) Phillips screws exposed on the right side of the underdash. Remove (2) Phillips screws from the driver's side knee bolster and (1) Phillips screw in the coin pocket. Remove (5) Phillips screws from the underdash panel and remove the panel. Remove (4) Phillips screws from the cupholder assembly and remove. Remove (2) Phillips screws securing the factory head unit and disconnect the wiring. (Fig. A)
- 3 Cut and remove all mounting clips on the **Radio Housing** EXCEPT clips "D" and "H" (Fig. A). Cut and remove the slots on the bottom of the **ISO Brackets** (Fig. B). (**THE REAR SUPPORT TRAY WILL NOT BE USED**). (Fig. B) Skip to step #3b on Page 10.

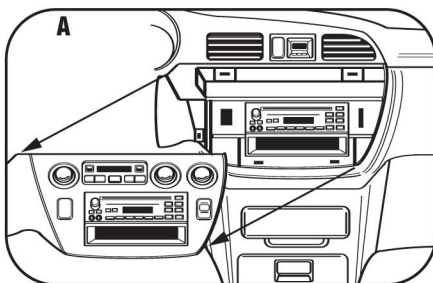
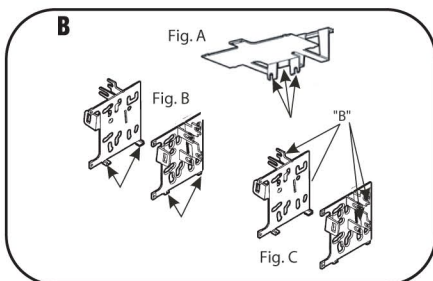
HONDA ODYSSEY 1999-2004

- 1 Disconnect the negative battery terminal to prevent an accidental short circuit.
- 2 Unclip the radio trim bezel (including the climate control panel) and remove. Remove (4) Phillips screws securing the factory head unit and disconnect the wiring. (Fig. A)
- 3 Cut and remove the mounting tabs from the bottom of the **Rear Support Tray** (Fig. A). Cut and remove the slots on the bottom of the **ISO Brackets** (Fig. B). Locate tabs "B" on the ISO Brackets for mounting, cut and remove tabs "A" (Fig. C). Cut and remove all mounting clips on the **Radio Housing**. (Fig. B) Skip to step #3b on Page 10.

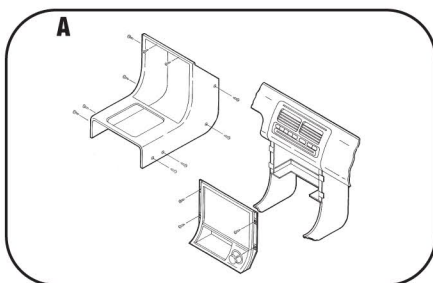
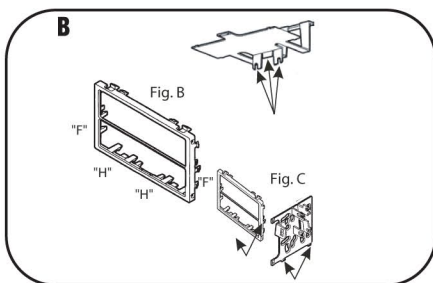
HONDA PRELUDE 1992-1996

- 1 Disconnect the negative battery terminal to prevent an accidental short circuit.
- 2 Remove (2) screws from the top of the console trim bezel. Slide the front seats back and remove (4) Phillips screws from each side of the bezel. Pull up on the console trim bezel and remove. Using an angled screwdriver, remove (2) screws securing the gear shifter bracket to the bezel. Remove (4) screws from the radio trim bezel, remove the factory head unit assembly and disconnect the wiring. (Fig. A)
- 3 Cut and remove the mounting tabs from the bottom of the **Rear Support Tray** (Fig. B). Cut and remove all mounting clips on the **Radio Housing** EXCEPT clips "F" and "H" (Fig. B). Cut and remove the slots on the bottom of the **ISO Brackets** (Fig. C). Skip to step #3b on Page 10.

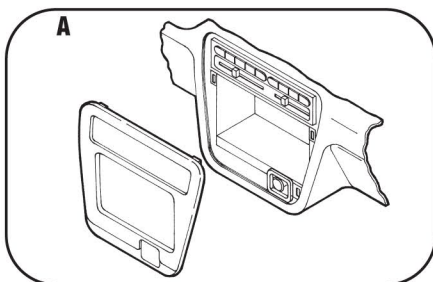
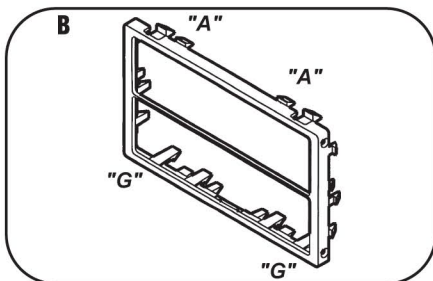
HONDA PRELUDE 1997-2001

- 1 Disconnect the negative battery terminal to prevent an accidental short circuit.
- 2 Using a panel removal tool, unclip the radio trim bezel and remove (some force may be required). Remove (4) Phillips screws securing the factory head unit/bracket housing assembly and disconnect the wiring. Remove (4) Phillips screws securing the factory head unit to the bracket housing and remove. (Fig. A)
- 3 Cut and remove all mounting clips on the **Radio Housing** EXCEPT clips "A" and "G". (Fig. B) Skip to step #3a on Page 9.

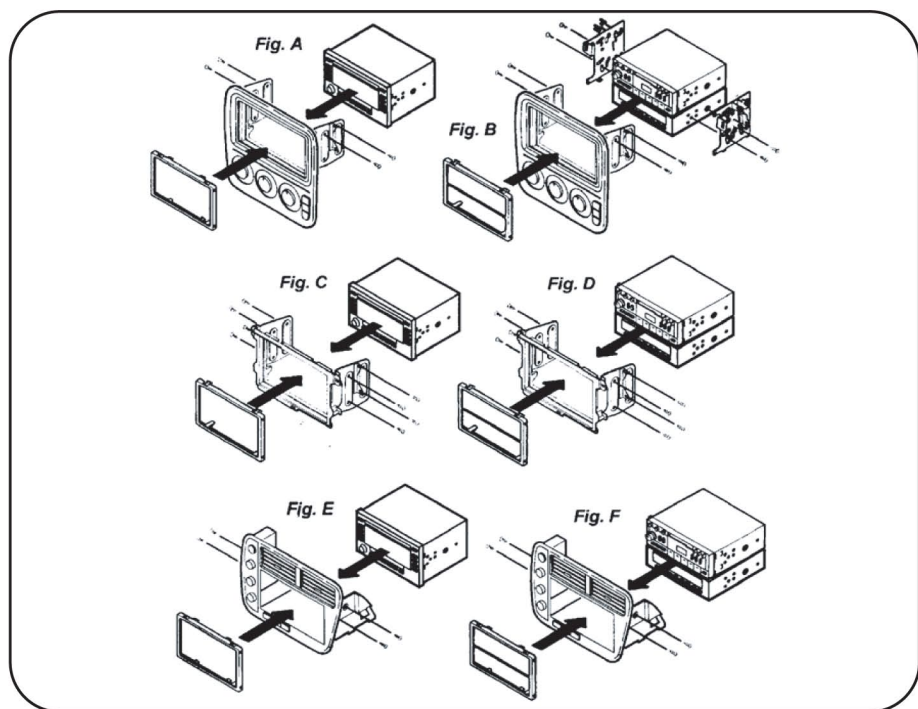
CRV: DOUBLE DIN HEAD UNITS: Slide the head unit into the factory bracket assembly. Align the holes in the brackets with the holes in the head unit and secure with the screws included with the unit. Cut and remove the dividing rib from the **Radio Housing** and snap the Housing into the opening (Fig. A). **Skip to step #4 on Page 11.**

ISO STACK HEAD UNITS: Slide the aftermarket head unit (and digital sound processor, equalizer, etc.) into the **ISO Brackets** and mount the lower unit to the Brackets with the screws included with the unit. Slide the units into the factory bracket assembly. Align the holes in the brackets with the holes in the upper unit and secure with the screws included with the unit. Snap the **Radio Housing** into the radio opening (Fig. B). **Skip to step #4 on Page 11.**

PRELUDE 1997-01: DOUBLE DIN HEAD UNITS: Slide the head unit into the factory bracket assembly. Align the holes in the brackets with the holes in the head unit and secure with the screws included with the unit. Cut and remove the dividing rib from the **Radio Housing** and snap the Housing into the opening (Fig. C). **Skip to step #4 on Page 11.** **ISO STACK HEAD UNITS:** Slide the aftermarket head unit (and digital sound processor, equalizer, etc.) into the factory bracket assembly. Align the holes in the brackets with the holes in the units and secure with the screws included with the units. Snap the **Radio Housing** into the radio opening (Fig. D). **Skip to step #4 on Page 11.** **CIVIC 1999-00: DOUBLE DIN HEAD UNITS:** Slide the head unit into the factory bracket assembly. Align the holes in the brackets with the holes in the head unit and secure with the screws included with the unit. Cut and remove the dividing rib from the **Radio Housing** and snap the Housing into the opening (Fig. E). **Skip to step #4 on Page 11.**

ISO STACK HEAD UNITS: Slide the aftermarket head unit (and digital sound processor, equalizer, etc.) into the factory bracket assembly. Align the holes in the brackets with the holes in the units and secure with the screws included with the units. Snap the **Radio Housing** into the radio opening (Fig. F). **Skip to step #4 on Page 11.**

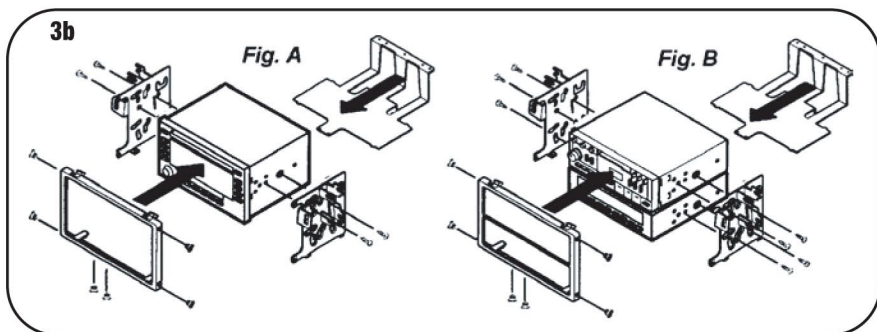
DOUBLE DIN RADIO PROVISION

STACKED ISO UNITS PROVISION

- 1 Disconnect the negative battery terminal to prevent an accidental short circuit.
- 2 **DOUBLE-DIN HEAD UNITS:** Cut and remove the dividing rib from the radio opening. Cut and remove all mounting tabs on the ISO Brackets, align the holes in the Brackets with the holes in the head unit and secure with the screws included with the unit. Slide the **Rear Support Tray** under the unit. Position the **Radio Housing** over the unit and mount to the ISO Brackets with (4) #6 x 1/4" Flat-head Screws supplied and to the **Rear Support Tray** with (2) #6 x 1/4" Flat-head Screws supplied (Fig. A). *Skip to Final Assembly on page 11 for Step 4.*

- 3 **ISO STACK HEAD UNITS:** Cut and remove all mounting tabs on the **ISO Brackets**, align the holes in the Brackets with the holes in the head units and secure with the screws included with the units. Slide the **Rear Support Tray** under the units. Position the **Radio Housing** over the units and mount to the ISO Brackets with (4) #6 x 1/4" Flat-head Screws supplied and to the **Rear Support Tray** with (2) #6 x 1/4" Flat-head Screws supplied (Fig. B). *Skip to Final Assembly on page 11 for Step 4.*

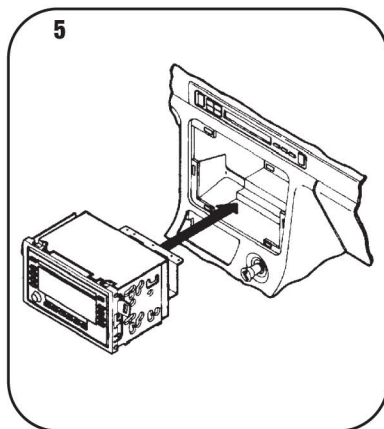
ACCORD 1994-97, CL: Secure the Mounting Bracket (mounted to the bottom of the Rear Support Tray) to the rear support provision in the sub-dash with (2) bolts previously removed. (*Skip to Final Assembly on page 11.*)

CRV, PRELUDE 1997-01, CIVIC 1999-00: Snap the head unit/trim bezel assembly into the sub-dash. (*Skip to Final Assembly on page 11.*)

ACCORD 1990-93, ODYSSEY 1995-98, PRELUDE 1992-96, INTEGRA, OASIS, VIGOR, TL: Snap the head unit/kit assembly into the sub-dash. **ACCORD 1998-02, ODYSSEY 1999-02:** Mount the head unit/kit assembly to the sub-dash with (4) screws previously removed in step #1. (*Skip to Final Assembly on page 11.*)
