Pacific Accessory Corporation

- Displaying video on far rear screen of the Cadillac Escalade ESV -

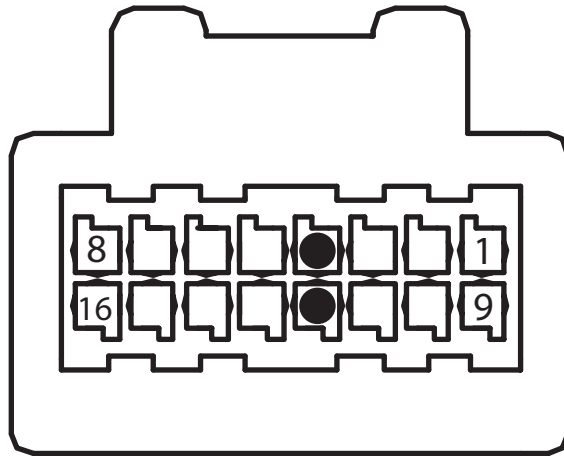
Solution: Below is a picture of the connector in which two wires need to be connected for video to be displayed on the far rear screen. For reference the Connector pictured below is purple in color and is located behind the radio and has the rear speaker leads in it as well. This is **NOT** the GMRVD connector.

Pin 4. - DVD Video Signal 2 (+) (Light Green)

Pin 12. - DVD Video Signal 2 (-) (White)

Symptoms: Video is not displayed on far rear screen.

Reason: We have found that there is a separate video feed for the far rear screen.
